MARINE INVESTIGATION REPORT

M99F0038

MAN OVERBOARD/DEATH

THE RAIL BARGE "JUNEAU", ACCOMPANIED BY THE TUGS
"SEASPAN PACER" AND
"ESCORT EAGLE"

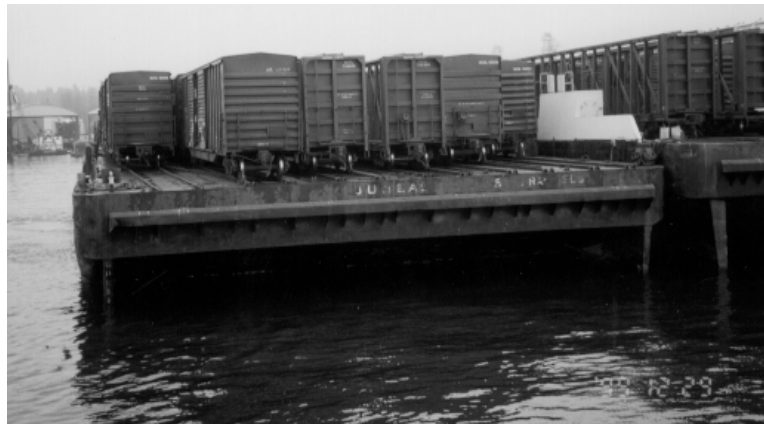
Figure 1 - The “JUNEAU” with rail cars on all six tracks

The barge “JUNEAU” is a steel, flat-deck, roll-on/roll-off barge, adapted to carry rail cars between specially designed loading ramps on the West Coast. Its bow and stern are flat and square, with rounded corners. Six pairs of railway tracks run the length of the deck. The “JUNEAU” is owned by a United States company, and is operated by the owners of the “SEASPAN PACER” on a bare-boat charter basis.

The "JUNEAU" has a wire rope safety line running along each side, supported by angle-iron stanchions welded to the deck. Positioned about 60 cm inboard from the edge of the deck, the line is about 90 cm high and ends about 4 m from the stern (see Figure 2).

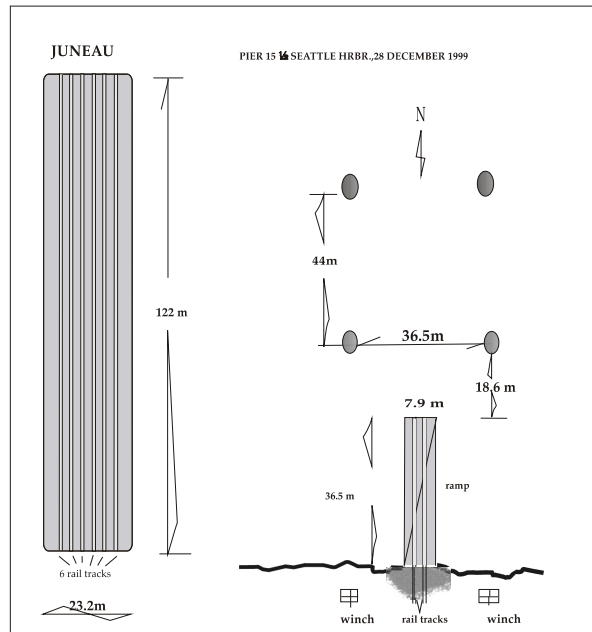
Figure 4

Pier 15½ in Seattle harbour is at the north end of Harbour Island in Elliott Bay. It is fitted with a ramp for loading rail cars via two rail tracks. The ramp is supported by a submerged buoyancy chamber; it is approximately 7.6 m wide and extends northward about 36 m from shore (see Figure 4).

Following a previously established pattern, the barge was manoeuvred, stern first, between the two outward dolphins. Subsequently the starboard quarter of the barge was brought to within 2 m of the inner, southeast dolphin to allow the crew on board to reach a polypropylene tag line attached to a wire mooring rope suspended from the dolphin's swivel block.
